Building Inspection Report

Inspection Date: August 14, 2028

1701 Enterprise

Report Overview

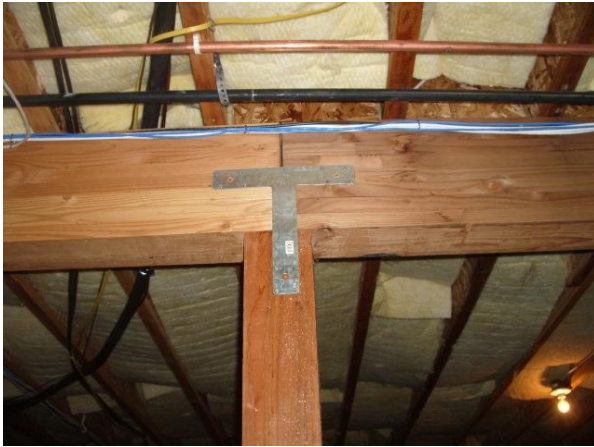
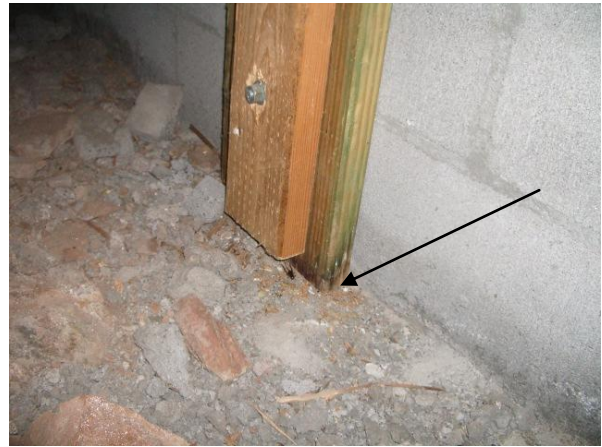
- ◇ The ends of some crawlspace beams are supported by wood posts bolted to the block stem walls. There is wood/soil contact at some of these posts. Ideally these posts should be trimmed off the soil to avoid wood/soil contact. The posts are bolted to the wall, but it would still be a good idea to install concrete blocks or pads under the posts. This is not considered a major defect- most of these posts are pressure treated wood which is resistant to insect and moisture damage. Any posts in contact with the soil should be monitored for moisture or insect damage.

- ◇ There is no evidence of significant or recent water in the crawlspace. There are some stains on the glu-lam beams, but these are not under plumbing lines. There are some stains at the bottom of some of the wood posts bolted to the block walls, and there are some rusty anchor bolts in areas. There are no recent stains in these areas. All of these may have occurred while the home was being built.

The glu-lam beams and floor trusses in the crawlspace are an upgrade over dimensional lumber. Some framing (“T”) straps are missing, one is shown in the left photo. There is minor wood/soil contact at some of the posts that are bolted to the block walls.

- ☑ Some framing ("T") straps at the post/beam connections in the crawlspace are missing. These should be installed, a minor task/expense.

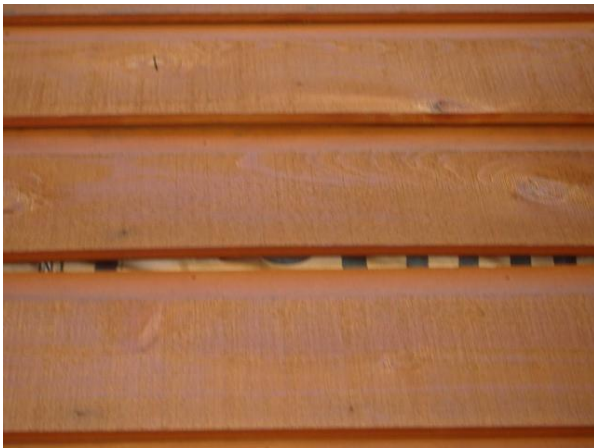
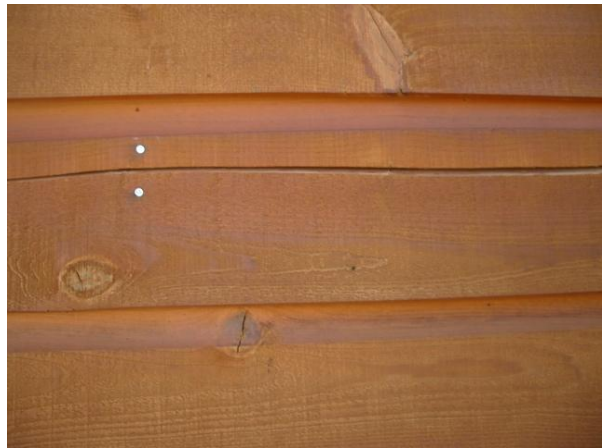
There are gaps and split boards at the wood siding.

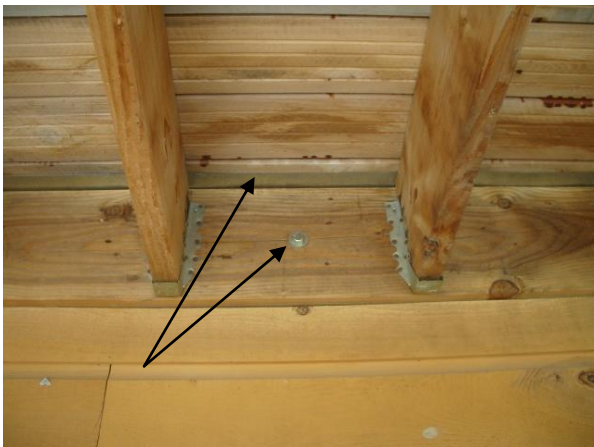
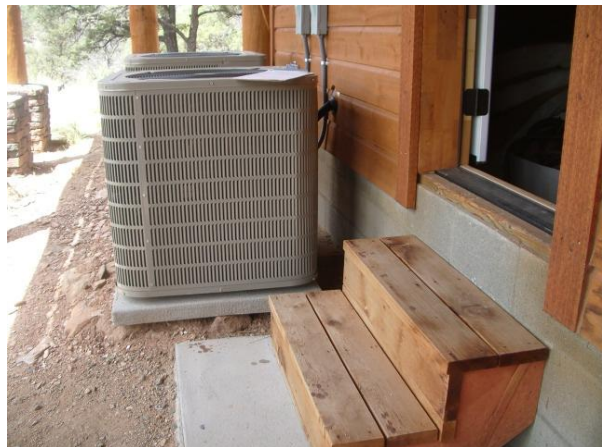
The framing at the decks is above average. Joist hangers are installed, the decks are bolted to the home, and there is flashing at the deck/home. The air conditioner compressors are closer to the home than ideal, and the soil is eroding from under the concrete pads under the compressors. There is a high step at the wood steps into the crawlspace.
